Manhole Inspection Summary

Manhole # S47AA_019MH

Insp Date: **6/23/08 10:44 AM**

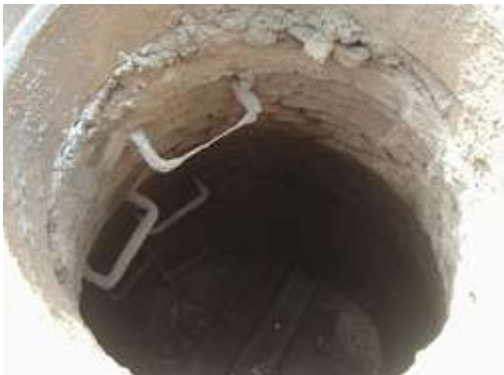
Defect 1

Condition: ☐ Sound ☐ Cracked ☐ Root Intrusion ☒ **Loose Brick** ☐ Deteriorated

deterioration

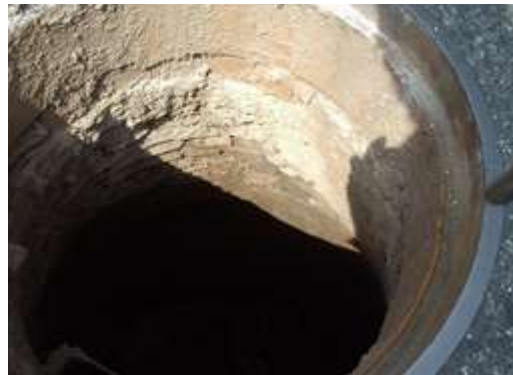
Defect 2

Infiltration: ☐ None ☒ **Joint** ☐ Cracks ☒ **Mortar** ☐ Roots ☐ Wall

infiltration

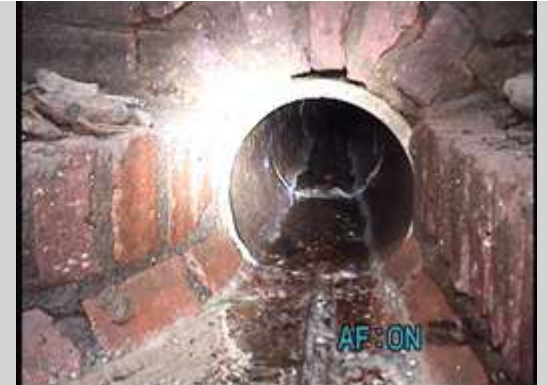
12 O'Clock Outflow

10 in. Circular Gravity Sewer
Pipe Out @ 12 O'Clock

Pipe Height: **10.8** (in.) Rod and Bar (Angled)
Pipe Material: **Clay** ☐ Pipe Lined
Invert Depth: **9.15** (ft.) Flow Characteristics: **Fast**
Deposits: ☒ None ☐ Mud ☐ Sludge ☐ Debris ☐ Grease
Silt Depth: (in.) Deposits Extent:
Infiltration: **None** Pipe Seal Cond: **Sound**

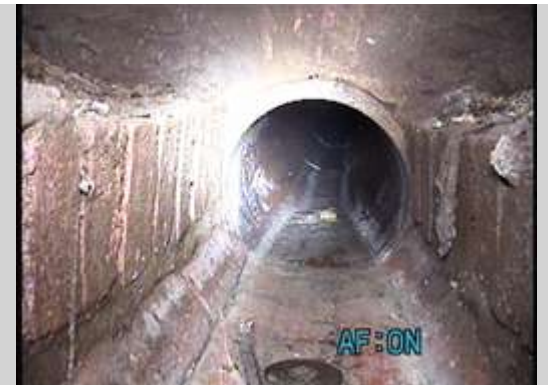
6 O'Clock Inflow

8 in. Circular Gravity Sewer
Pipe In @ 6 O'Clock

Pipe Height: **8.4** (in.) Rod and Bar (Angled)
Pipe Material: **Clay** ☐ Pipe Lined
Invert Depth: **9.10** (ft.) Flow Characteristics: **Fast**
Deposits: ☒ None ☐ Mud ☐ Sludge ☐ Debris ☐ Grease
Silt Depth: (in.) Deposits Extent:
Infiltration: **None** Pipe Seal Cond: **Sound**

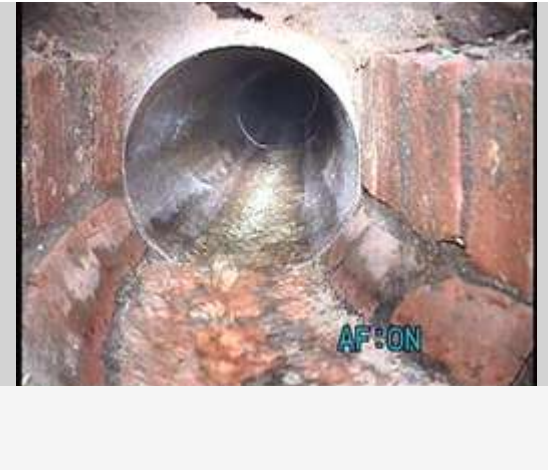
9 O'Clock Inflow

8 in. Circular Gravity Sewer

Pipe In @ 9 O'Clock

Infiltration: **None** Pipe Seal Cond: **Sound**
